Image Collection for Non-Segmenting Approach of Timber Surface Defect Detection

Abstract

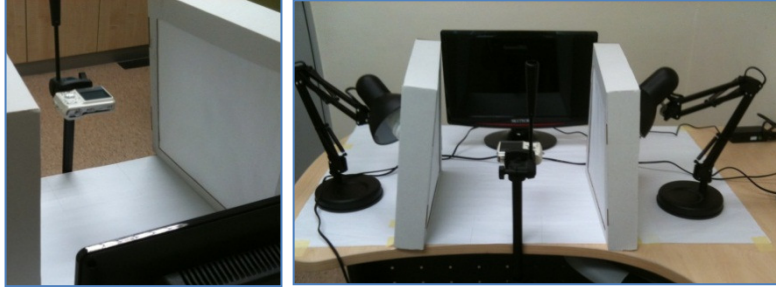
Fig. 1: Image Acquisition Setup

The imaging setup for our study comprised of a charged-coupled device (CCD) digital camera with controlled illumination inspired by previous studies using similar type of digital camera [26, 35–37]. The camera is mounted on a fixed tripod and positioned to face the top of inspection table as shown in fig. 1. A fixed distance between samples and camera is maintained throughout the acquisition process. Compact fluorescent lighting with diffuser is used and located at both side of the inspection area with an angle of approximately 45 degrees, adjusted to obtain uniform illumination over the samples. The camera is configured for a 17cm view, which is enough to cover most samples' width, with a resolution of 1024 by 768 pixels (300dpi). Previous studies as in Table 6 provide some indication that this resolution is sufficient for most application of timber defect detection. The images captured were of 24 bit depth, containing 256 intensity levels for each colour channel (red, green and blue). These basic channel is considered sufficient as it was reported that transforming RGB to other colour spaces for wood images yield no significant advantage [38]. H. Kauppinen & Silven[39] further agreed that classification accuracy of knot detection from

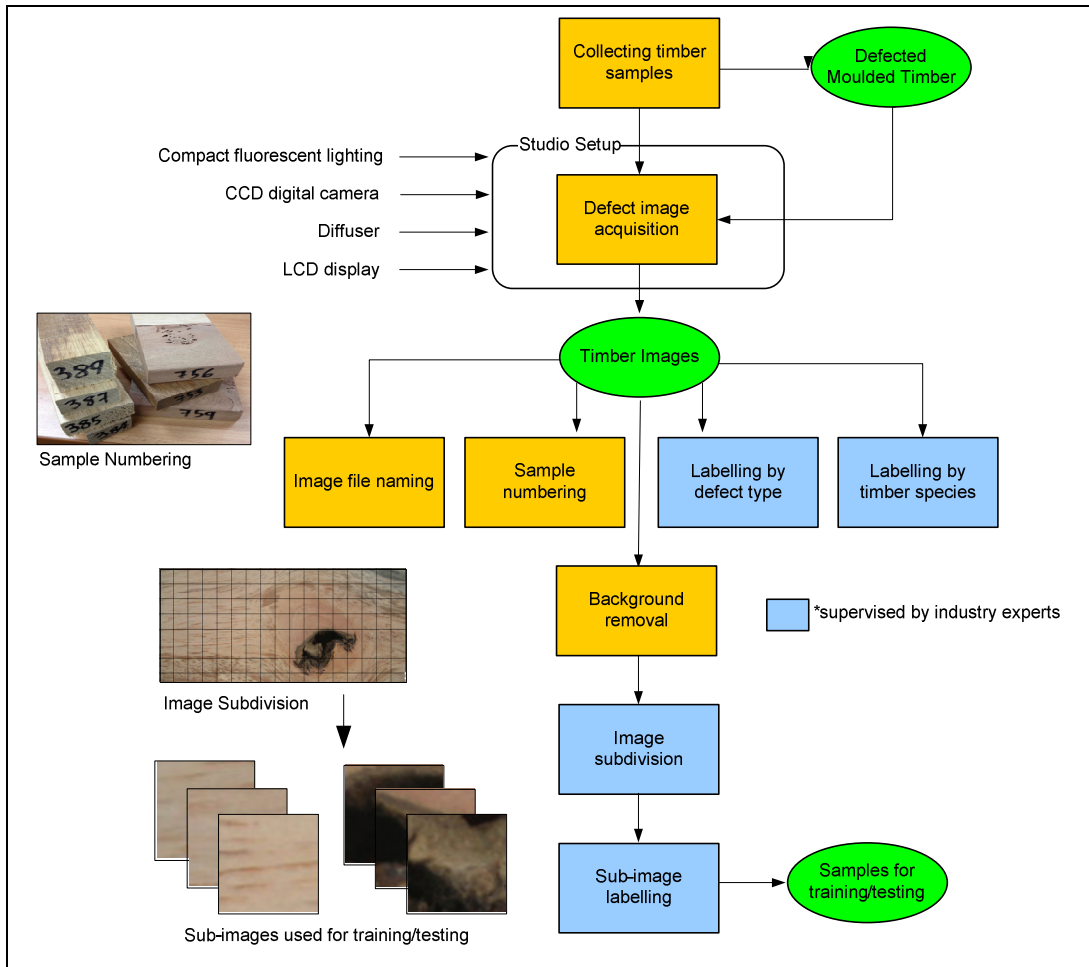
Fig. 2: Data Collection Process

Fig. 2 illustrates the overall process of data collection for our study. Timber surface images were captured using the low-cost acquisition setup described in section 2.2. The timber samples were marked with sequential numbering for reference. Subsequently, the image files related to the surface of the timbers were named using similar numbering. The images were then labelled and sorted according to wood species and defects present, supervised by industry experts.

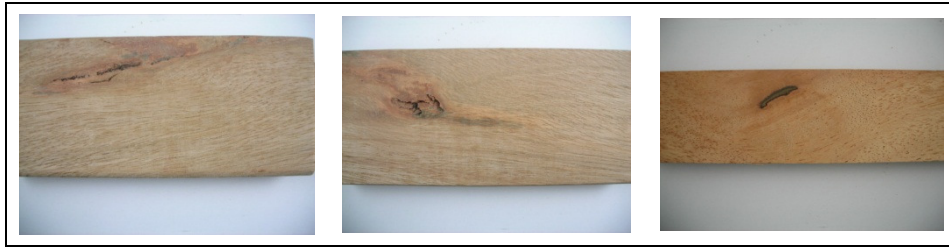
Fig. 3: Sample of images acquired

Fig. 3 shows some examples of image acquired. Each sample will contain at least a defect. Image of the timber is acquired twice per timber samples, on both top and bottom surfaces.

The images as shown in fig. 3 contain some background which is not part of the timber. This background was cropped manually to remove background area. Weidenhiller & Denzler[15] similarly marked the background manually in his work, claiming that for later application, additional processing may separate the samples from its background.
